# **Intel<sup>®</sup> Mobile Pentium<sup>®</sup> II Processor Specification Update**

Release Date: March 2000

Order Number: 243887-019

The Mobile Pentium<sup>®</sup> II processor may contain design defects or errors known as errata which may cause the product to deviate from published specifications. Current characterized errata are documented in this Specification Update.

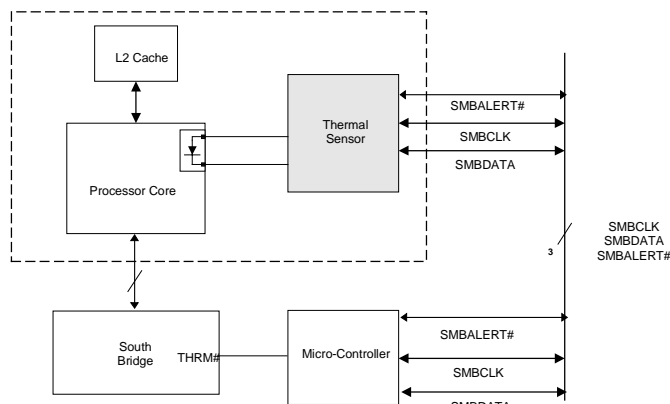
**Figure 1. An Example of Microcontroller Driven Thermal Management**

**Problem:** The Mobile Pentium II processor and the Pentium II Processor Mobile Module have a thermal sensor that monitors the processor core's temperature. Please note that desktop systems could have a similar thermal device. The thermal sensor asserts SMBALERT# if the processor temperature exceeds the temperature limits set in the Alarm Threshold Registers ( $T_{HIGH}$ ,  $T_{LOW}$ ). It also sets the corresponding Status Register bits to identify the cause of the interrupt. Figure 1 gives one example of the how the SMBALERT# signal could be used in a system.

Under the conditions described below, the thermal sensor incorrectly generates the SMBALERT# interrupt. All of the following conditions must be met to trigger a false interrupt:

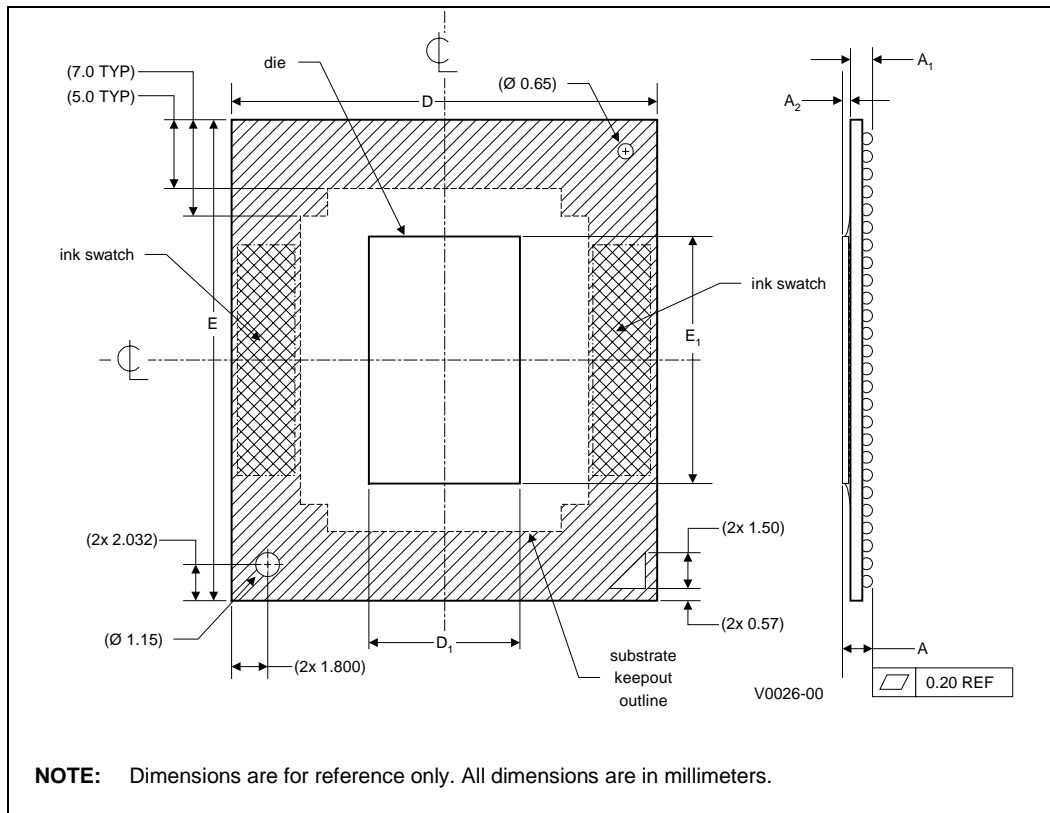
**Figure 5.3. Surface-Mount BGA1 Package—Top and Side View**

The following table and figures show the updated mechanical specifications for the BGA1 package, listed as Table 5.2, Figure 5.3 and Figure 5.4, respectively, in the *Mobile Pentium® II Processor in BGA Package at 366 MHz, 333 MHz, 300PE MHz, and 266PE MHz* datasheet.

1. The number shown here is different from that in the 243887-010 revision of this specification update. The maximum reference number is used.
